ARKDALE LAKE LAKE CLASSIFICATION REPORT

**Presented by Reesa Evans, CLM, Lake Specialist
Adams County Land & Water Conservation Department
P.O. Box 287, Friendship, WI 53934**

MARCH 2008

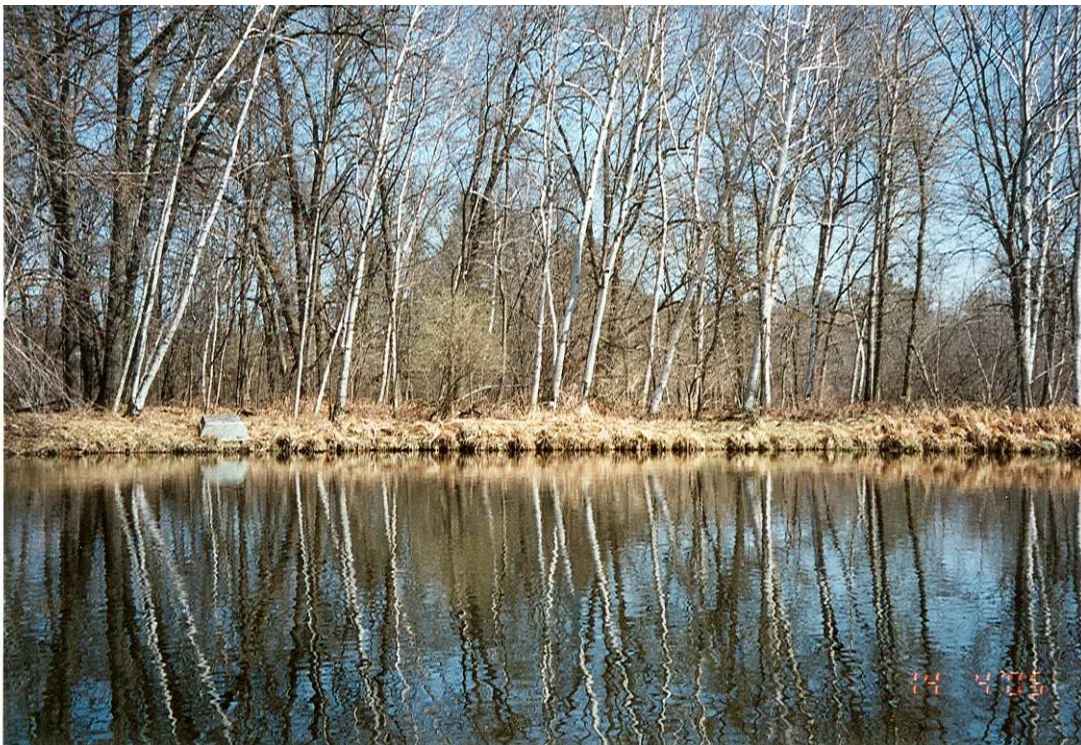
Figure 8: Arkdale Lake wooded shore wetland

The photo above (Figure 8) shows one of the wetlands along the shore of Arkdale Lake. Looking at the map of wetlands directly around Arkdale Lake (see Figure 9) makes it evident how important wetlands are to Arkdale Lake...much of the lake has wetlands at or near the shore that serve as filters and trappers that help keep the lake as clean as it is. It is essential to preserve these wetlands for the health of Arkdale Lake.

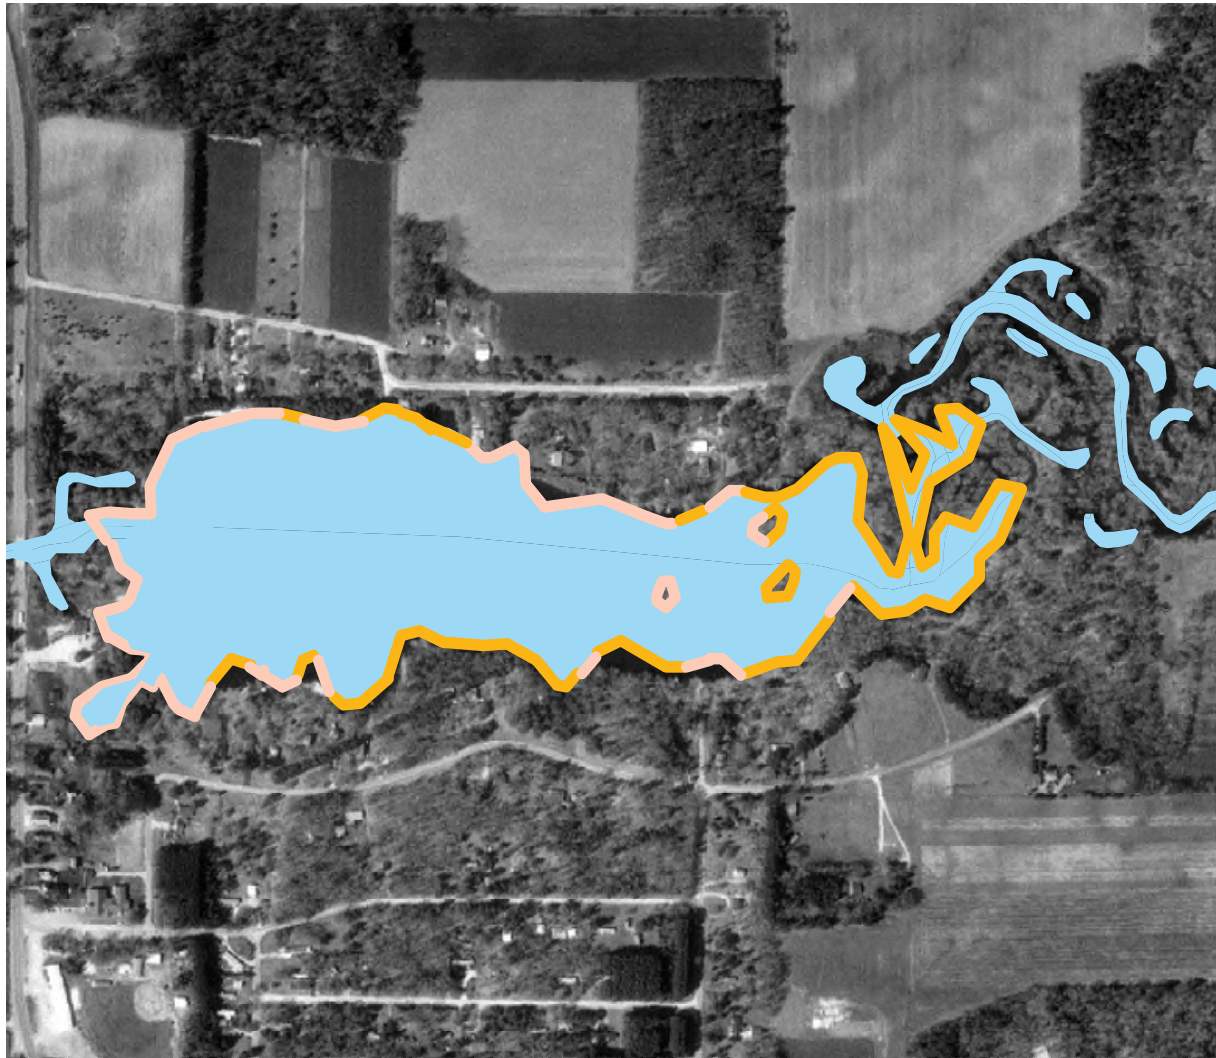
Buffers on Arkdale Lake

Vegetated shoreland buffers help stabilize shoreline banks, thus reducing bank erosion. The plant roots give structure to the bank and also increase water infiltration and decrease runoff. A vegetated shore is especially important when shores are steep and soft, as are many of the Arkdale Lake shores. Figure 13 maps the adequate and inadequate buffers on Arkdale Lake.

The 2004 inventory included classifying areas of the Arkdale Lake shorelines as having “adequate” or “inadequate” buffers (see Figure 13). An “adequate” buffer was defined as one having the first 35 feet landward covered by native vegetation. An “inadequate” buffer was anything that didn’t meet the definition of “adequate buffer”, including native vegetation strips less than 35 feet landward. Using these definitions, 65.67% (about 8126 feet) of Arkdale Lake’s shoreline had an “adequate buffer”, leaving 35.33% (4440 feet) as “inadequate.” Most of the “inadequate” buffer areas were found with traditional mowed lawns and/or insufficient native vegetation at the shoreline to cover 35 feet landward from the water line.

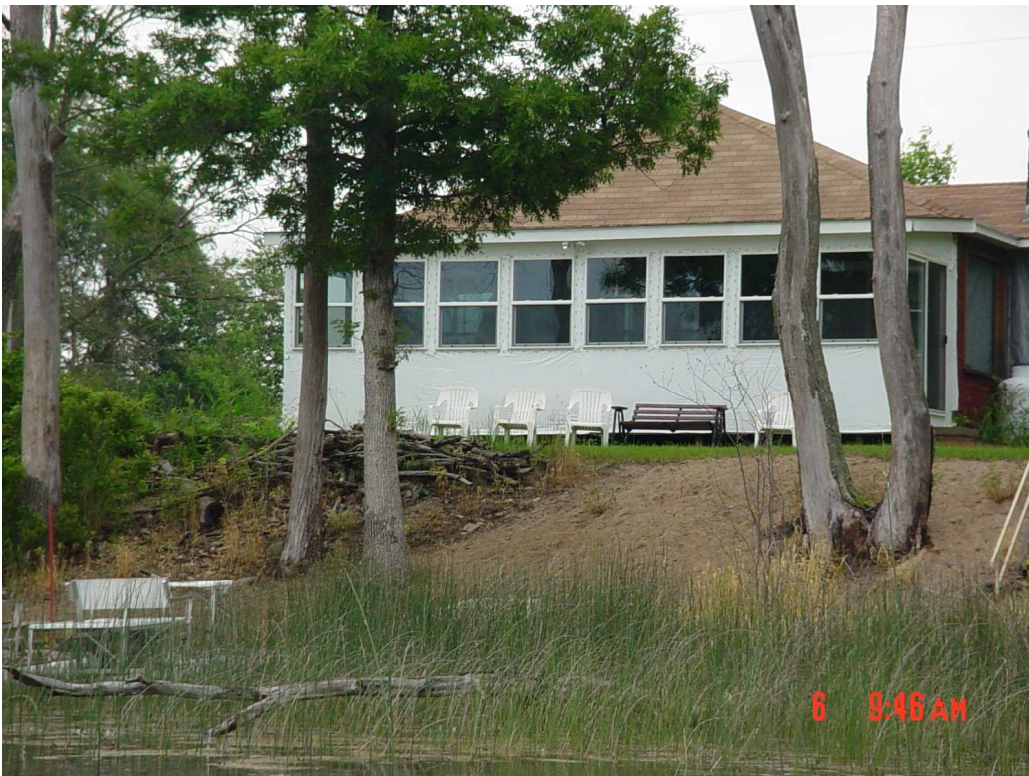
Figure 14: Example of Inadequate Vegetative Buffer

When the natural shoreline is replaced by traditional mowed turf-grass lawns, rock, wooden walls or similar installments, bird and animal life, land-based insects, and aquatic insects that hatch or winter on natural shore are negatively impacted. For example, on many Adams County lakes, the non-native aquatic plant, Eurasian Watermilfoil has invaded. There is a weevil native to Wisconsin that weakens Eurasian Watermilfoil by burrowing into and developing within its stems, but that weevil depends on a native-plant shore to overwinter. If the shore is instead covered by rock, seawall or traditional lawn, these weevils will be unavailable for the lake to use as Eurasian Watermilfoil control.

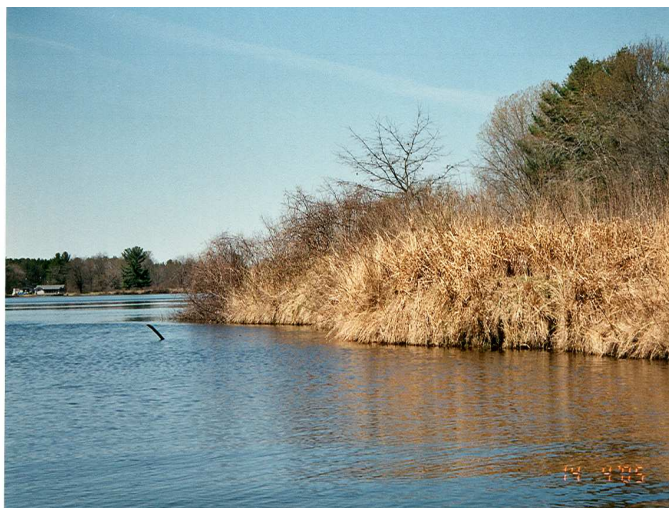
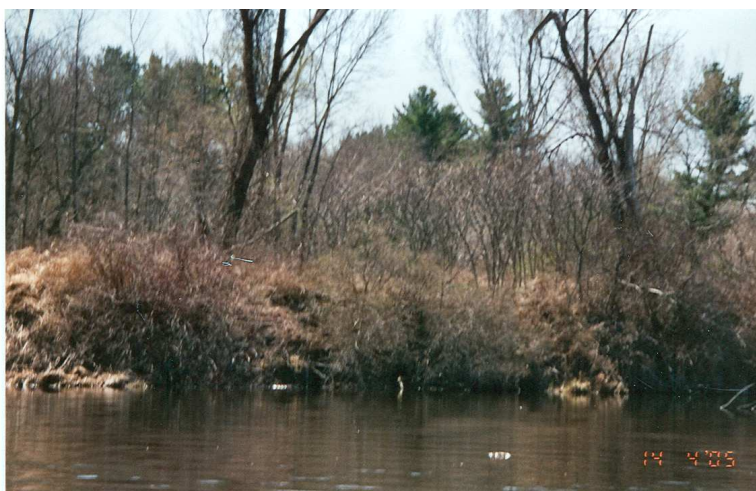
Figure 45: Various photos of AR1

This area extends along the entire northeast end of the lake and the eastern end of the north shore, with an average water depth of less than 2' in the most eastern end and of less than 3' along the north shore. Sediment includes muck, silt and mixtures thereof. 25% of the shore is wooded; 55% is native herbaceous cover and 20% is shrubs. Some woody cover is present for habitat. Human disturbance impact on this area is currently limited, perhaps partially due to the very shallow waters.

Aquatic vegetation found at AR1 included six emergent plants, two free-floating plants and six submergent species. Emergents provide important fish habitat and spawning areas, as well as food and cover for wildlife. The free-floating species are used for food and cover by various fish and wildlife. Filamentous algae were also abundant here.
